Drainage Work Order Request For Repair

Hardin County

Work Order # 91

Landowner located in the NE¼ of Section 24, Township 88 North, Range 20 West reported a tile blowout. Upon talking with District Trustees, they authorized televising while tile was open for repairs. Excavated at blowout and found broken and egged shaped 22" VCP main tile.

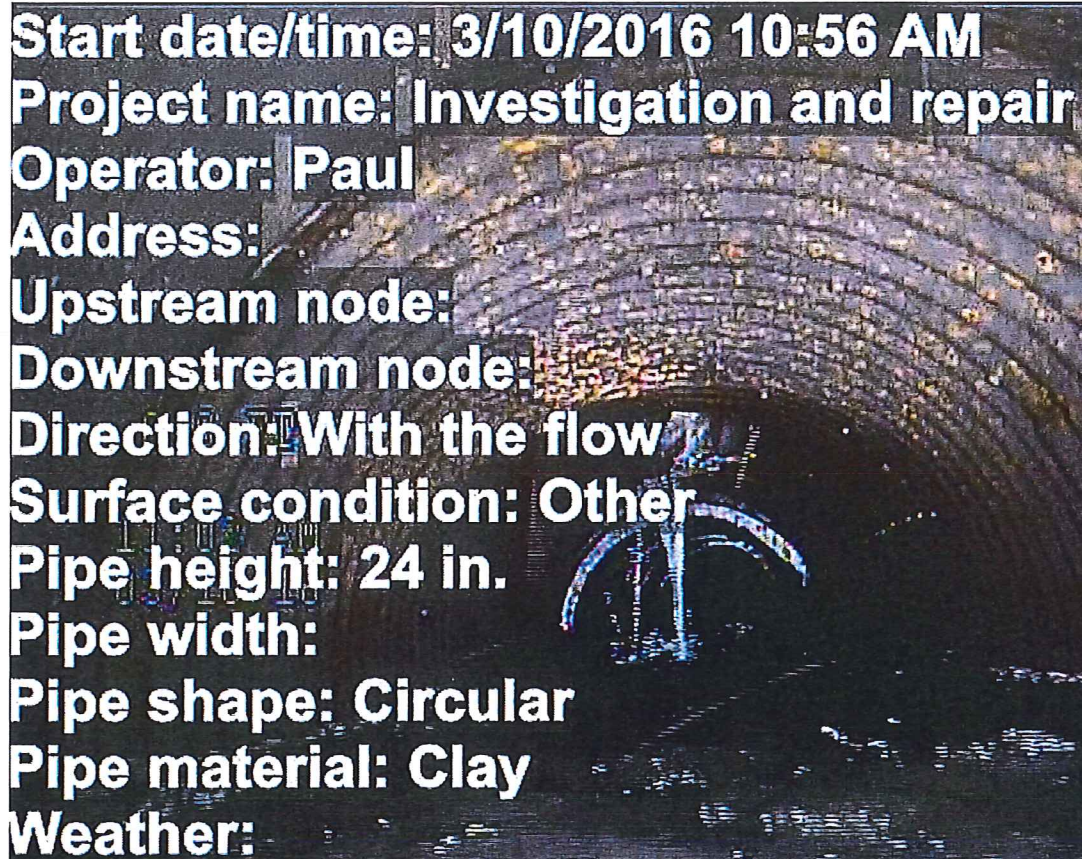
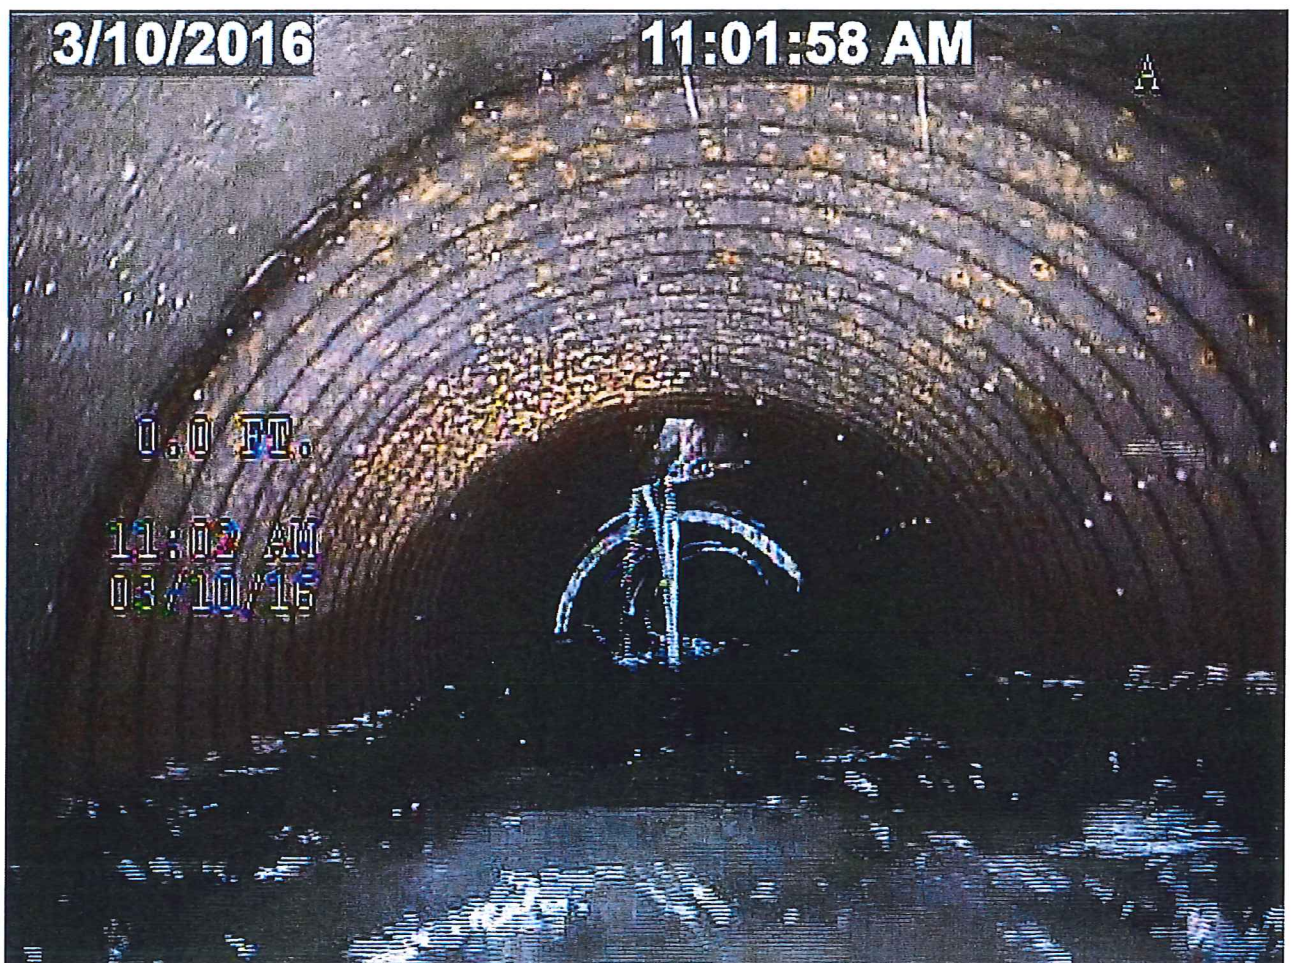
Start date/time: 3/10/2016 10:56 AM
Project name: Investigation and repair
Operator: Paul
Address:
Upstream node:
Downstream node:
Direction: With the flow
Surface condition: Other
Pipe height: 24 in.
Pipe width:
Pipe shape: Circular
Pipe material: Clay
Weather:

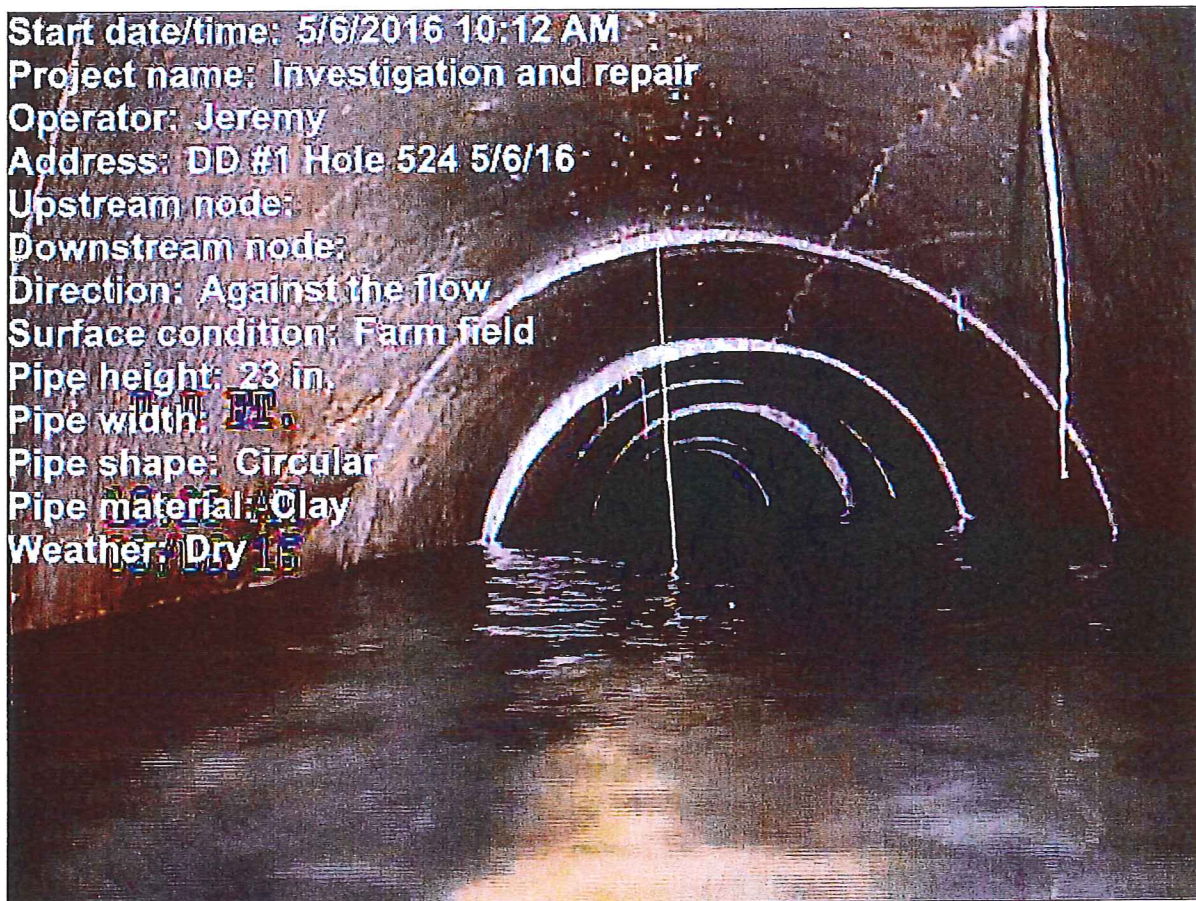
Start date/time: 5/6/2016 10:12 AM
Project name: Investigation and repair
Operator: Jeremy
Address: DD #1 Hole 524 5/6/16
Upstream node:
Downstream node:
Direction: Against the flow
Surface condition: Farm field
Pipe height: 23 in.
Pipe width: 22 ft.
Pipe shape: Circular
Pipe material: Clay
Weather: Dry 15

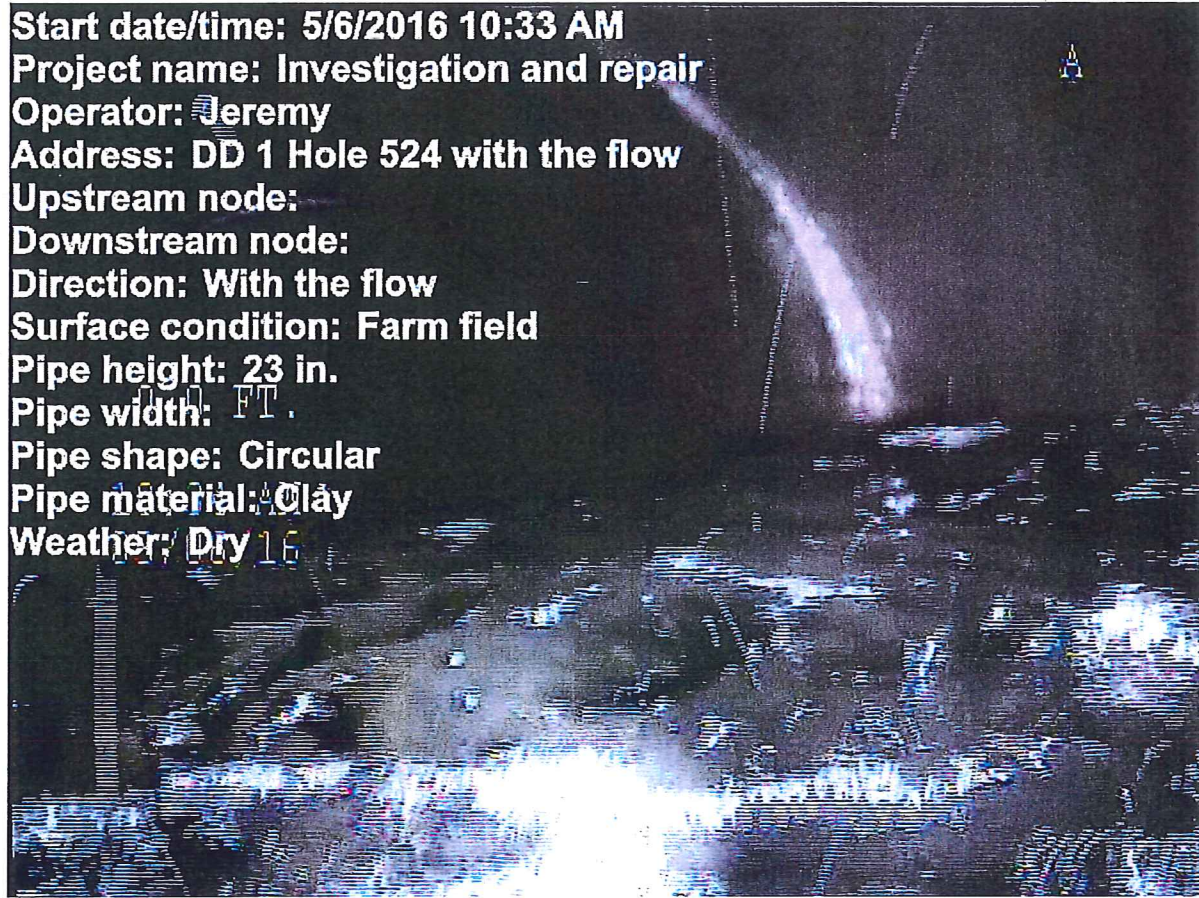
Start date/time: 5/6/2016 10:33 AM
Project name: Investigation and repair
Operator: Jeremy
Address: DD 1 Hole 524 with the flow
Upstream node:
Downstream node:
Direction: With the flow
Surface condition: Farm field
Pipe height: 23 in.
Pipe width: FT.
Pipe shape: Circular
Pipe material: Clay
Weather: Dry

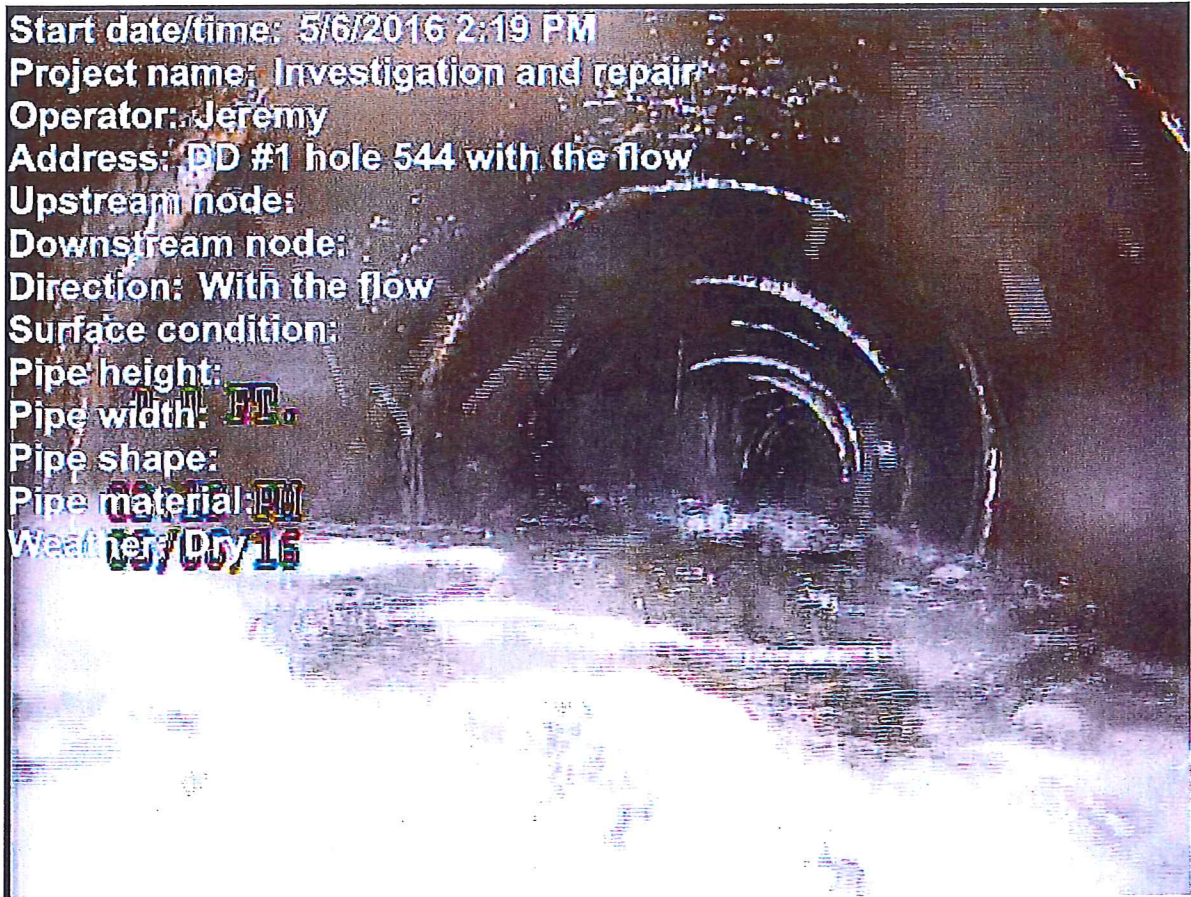
Start date/time: 5/6/2016 2:19 PM
Project name: Investigation and repair
Operator: Jeremy
Address: PD #1 hole 544 with the flow
Upstream node:
Downstream node:
Direction: With the flow
Surface condition:
Pipe height:
Pipe width: 11 FT.
Pipe shape:
Pipe material: PM
Weather: Dry
